State Water Board Report Finds No Evidence of Plume Source on Kilham Mine Road

South Yuba River Plume Investigation Continues

By Nevada County Environmental Health Department - November 27, 2019, 03:25:58 PM

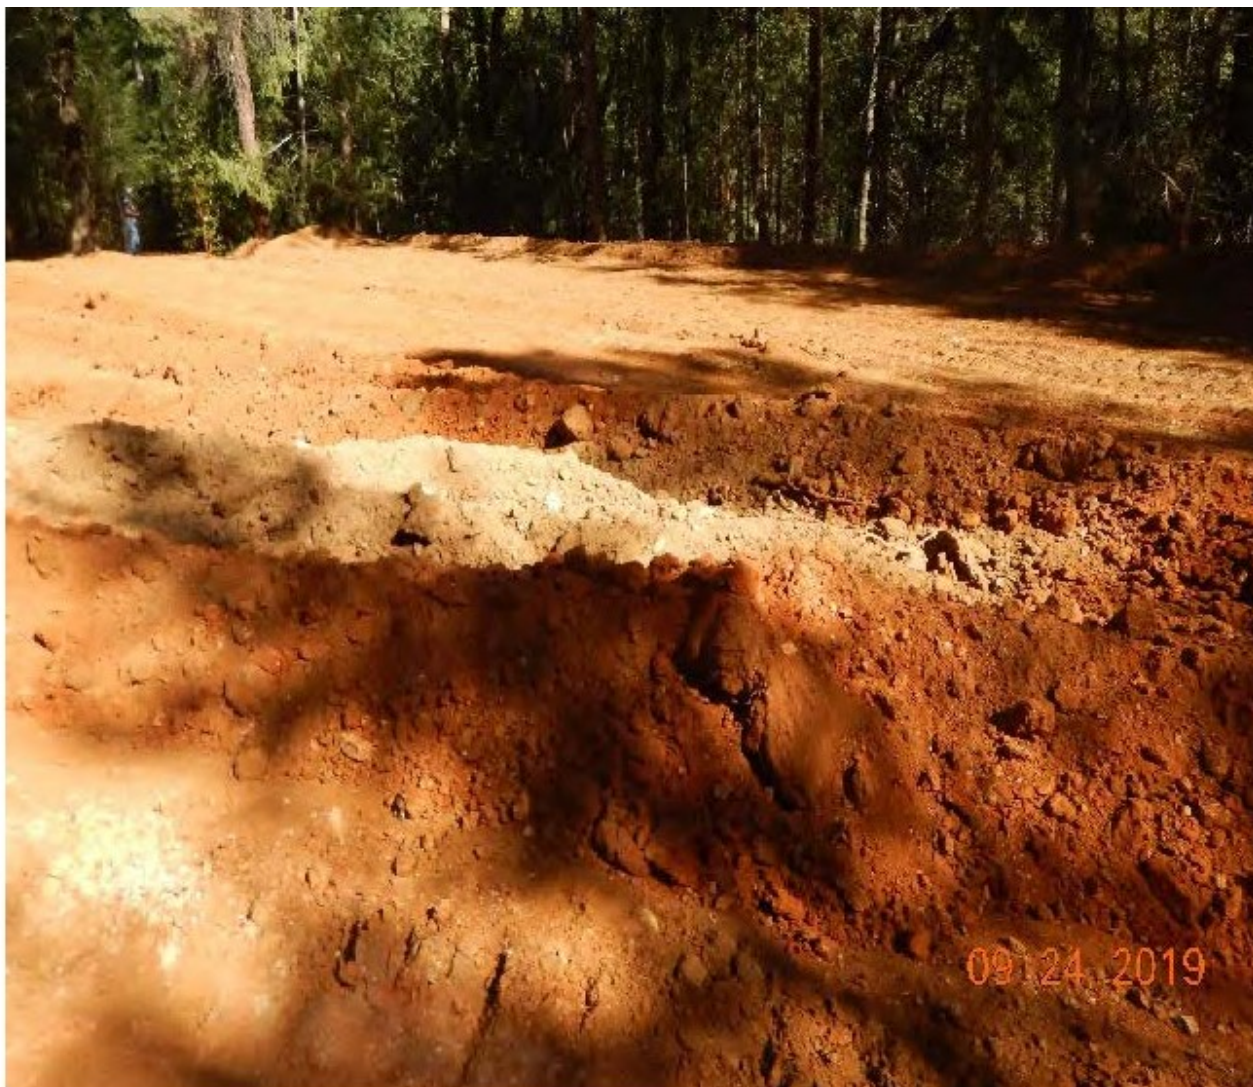
Freshly graded pad along the Northern Access Road.

However, land disturbances greater than one acre that require coverage under the Construction Storm Water General Permit and code violations were observed during the inspections. The State Water Board findings from site inspections conducted on September 24th and September 30th indicated staff observed three graded areas and regrading of an access road that measured to be over one acre in total. The property owner was required to enroll under the Construction Storm Water General Permit and stabilize the disturbed areas at the site and was issued a Storm Water Notice of Non-Compliance.
